INJECTOR CLEANING & ENGINE OIL FILTER REPLACEMENT

KCE09-14-P200-BL | Service Action

| GR./Sys./komp. | Fuel System / Fuel Delivery System / Fuel Line | | |
| Model | SORENTO(BL) | 2006 | |

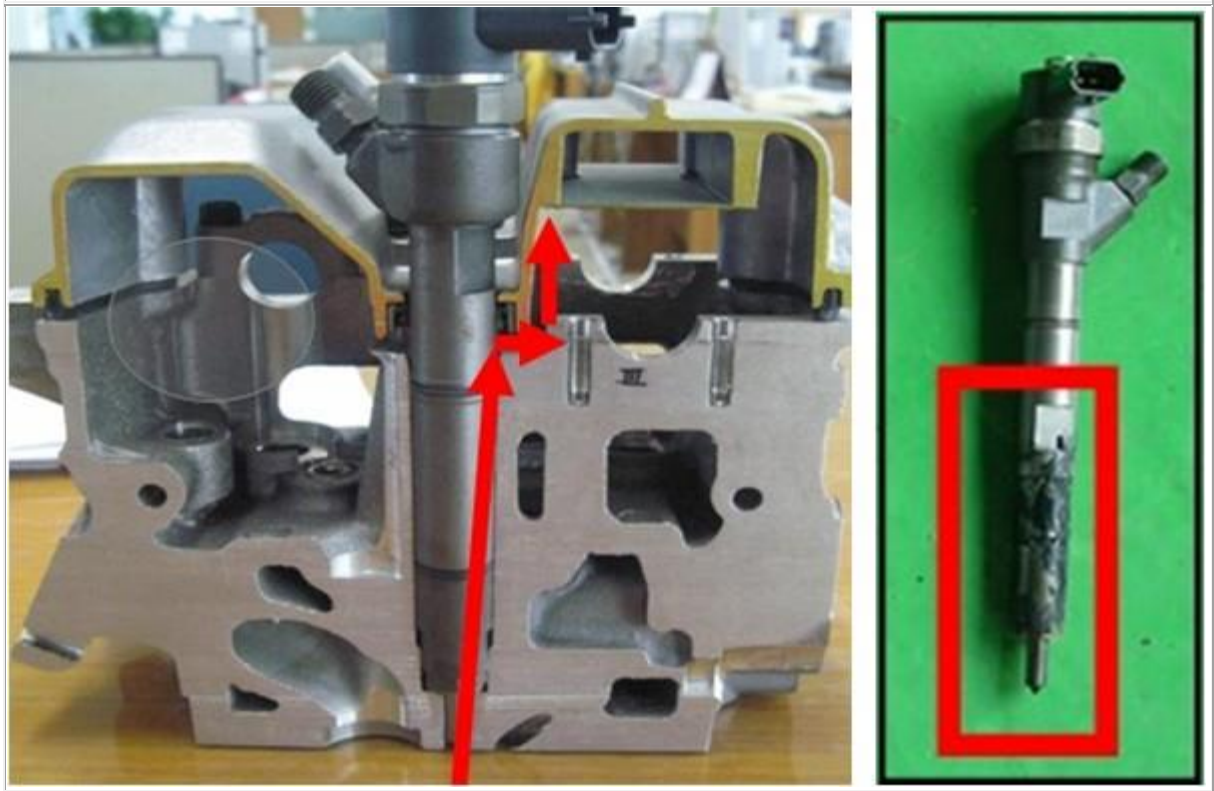
- Symptom/Condition  
Some Sorento (BL) vehicles with 2.5L A-engine may experience damage of turbocharger.
- Cause  
Gas leaking from the cylinder is mixed with engine oil in the engine head cover. It results into quality deterioration of engine oil.

Gas leaks from injector & cylinders

- Countermeasure/Remedy  
For all affected vehicles, clean all injectors' body and injector mounting holes in the engine head assembly following the Service Procedure below.

Plus, once any gas leak from injectors has been occurred and detected, replace the engine oil filter with the new one.

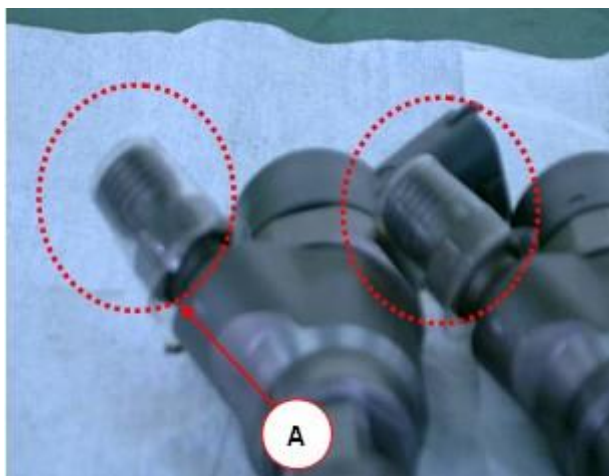
2. Plug caps (A) onto the inlets of all the removed injectors as shown on the photo to prevent foreign materials from entering into injectors.

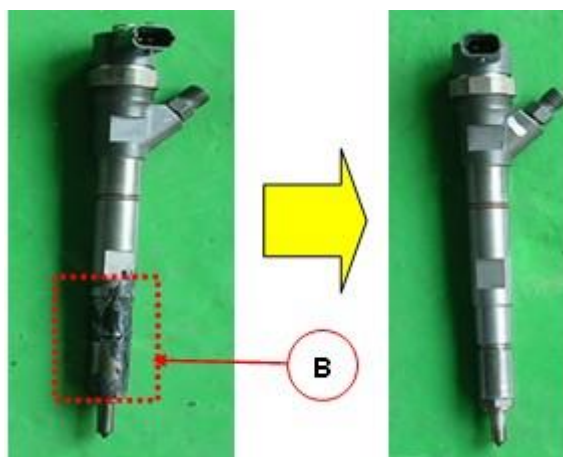
3. With alcohol cleanser clean off carbon deposits from the injector body (B).

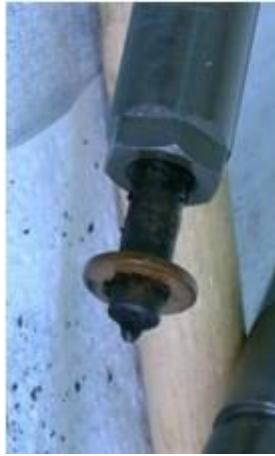
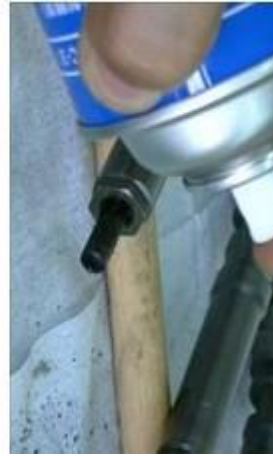
4. Remove the injector gasket (C) from the injector nozzle.

5. Spray alcohol cleanser on the injector nozzle enough to make cleanser run down from the injector nozzle.

6. With a clean fabric remove carbon deposits from the injector nozzle.

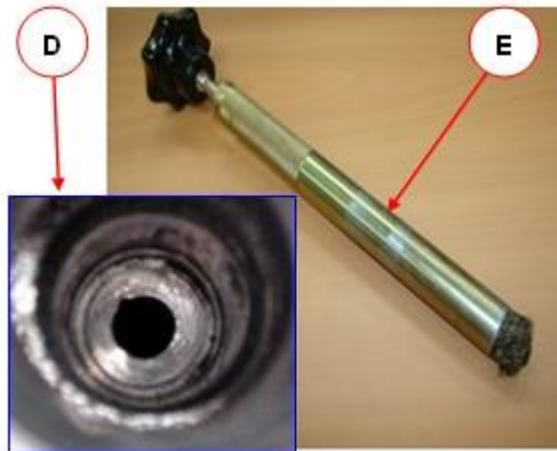
7. Using the SST (E) remove carbon deposits from injector mounting holes (D) in the engine head assembly.

\* SST  
: 09351-27300 (injector hole cleaning brush)

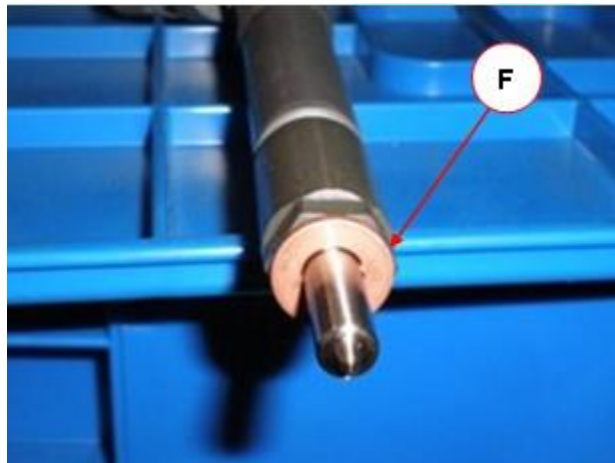
8. Insert each injector nozzle into a new injector gasket (F) and reinstall all the removed injectors.

**Caution)**  
**When tightening injector clamp bolts, make sure to use the specified torque.**

**-Tightening torque**  
**2.9~3.4 kgf-m (28.4~33.3 N-m,**  
**21.0~24.6 lbf-ft)**

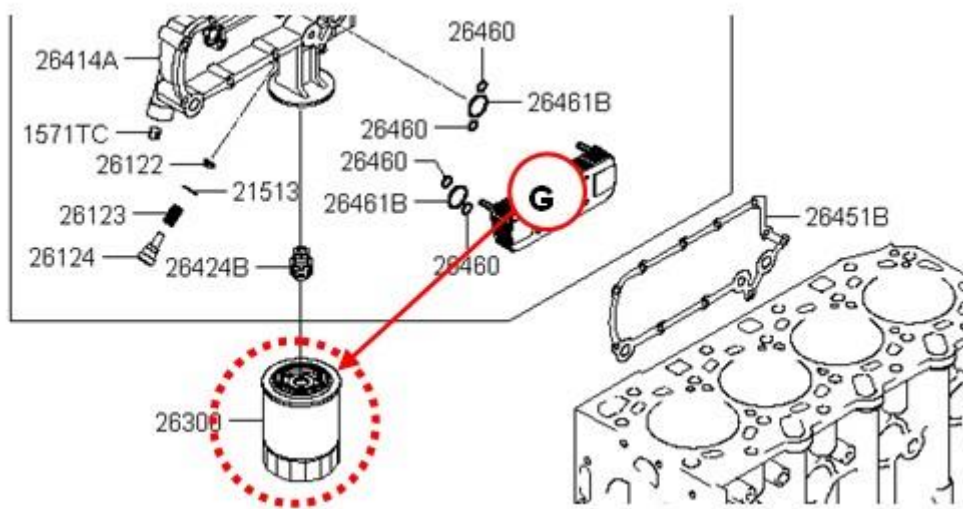
9. In case any gas leak from injectors has been detected as below, replaced the engine oil filter (G) with a new one.

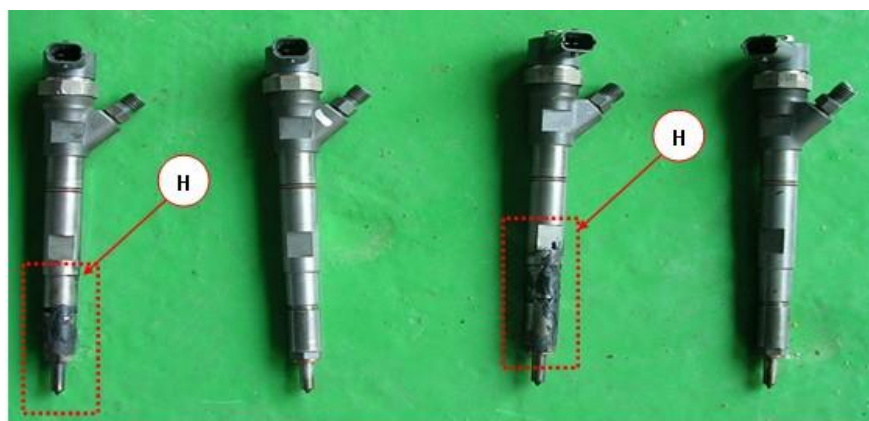
\* Results of gas leakage from injector

1) Carbon deposits (H) on injector body

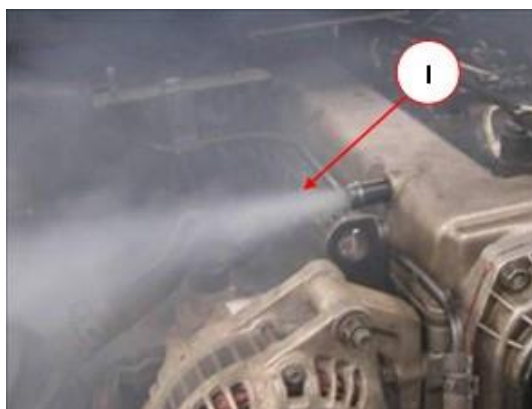
2) Excessive blow – by gas(I)
